Stafford, A and Lilley, D (2012) Predicting in situ heat pump performance: An investigation into a single ground-source heat pump system in the context of 10 similar systems. *Energy and Buildings*, 49. 536 - 541. ISSN 0378-7788 DOI: <https://doi.org/10.1016/j.enbuild.2012.03.001>

Predicting In-situ Heat Pump Performance: An Investigation into a Single Ground-Source Heat Pump system in the context of 10 similar systems.

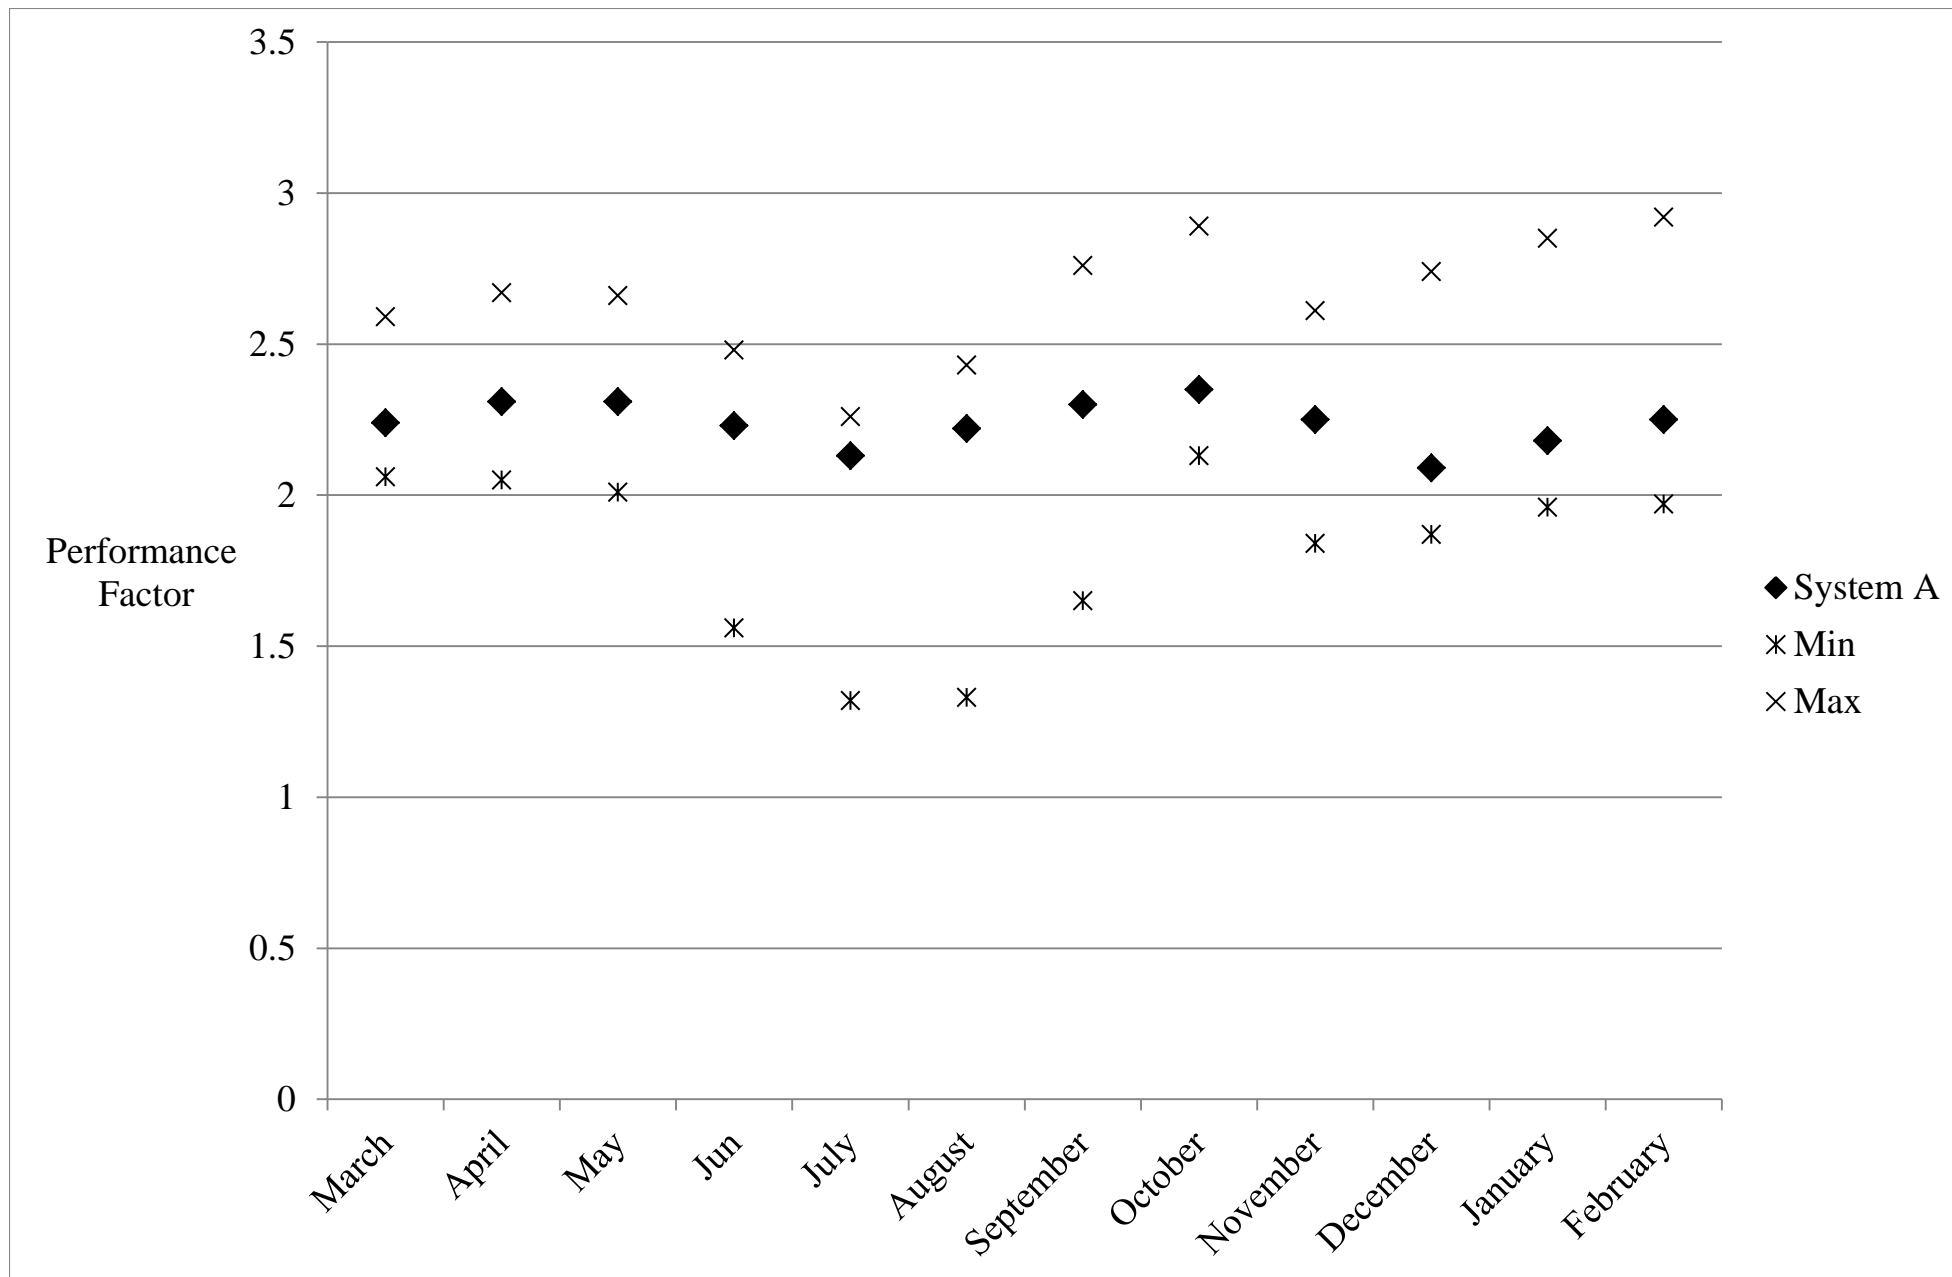
Fig 1: Month by Month Performance Factor of System A, compared with the maximum and minimum performance factors from all 10 systems.

Fig 1 shows the performance factor of system A on a month by month basis, during this year. The spread of values from all 10 systems is also shown in the diagram.

Whilst system A is at no time the best or worst performing system in the group, Fig 1 shows that it is performing relatively well during the summer months, when many of the systems show a significant drop in performance (due to the output being dominated by DHW production). Similarly, the performance in the winter months is relatively poor compared with the other nine systems. In itself this might suggest that this system is producing DHW relatively efficiently, and space heating relatively inefficiently compared with the remainder of the group.

Thus both Fig 1 and Fig 2 suggest that the heat pump system A is performing relatively well with respect to DHW production.

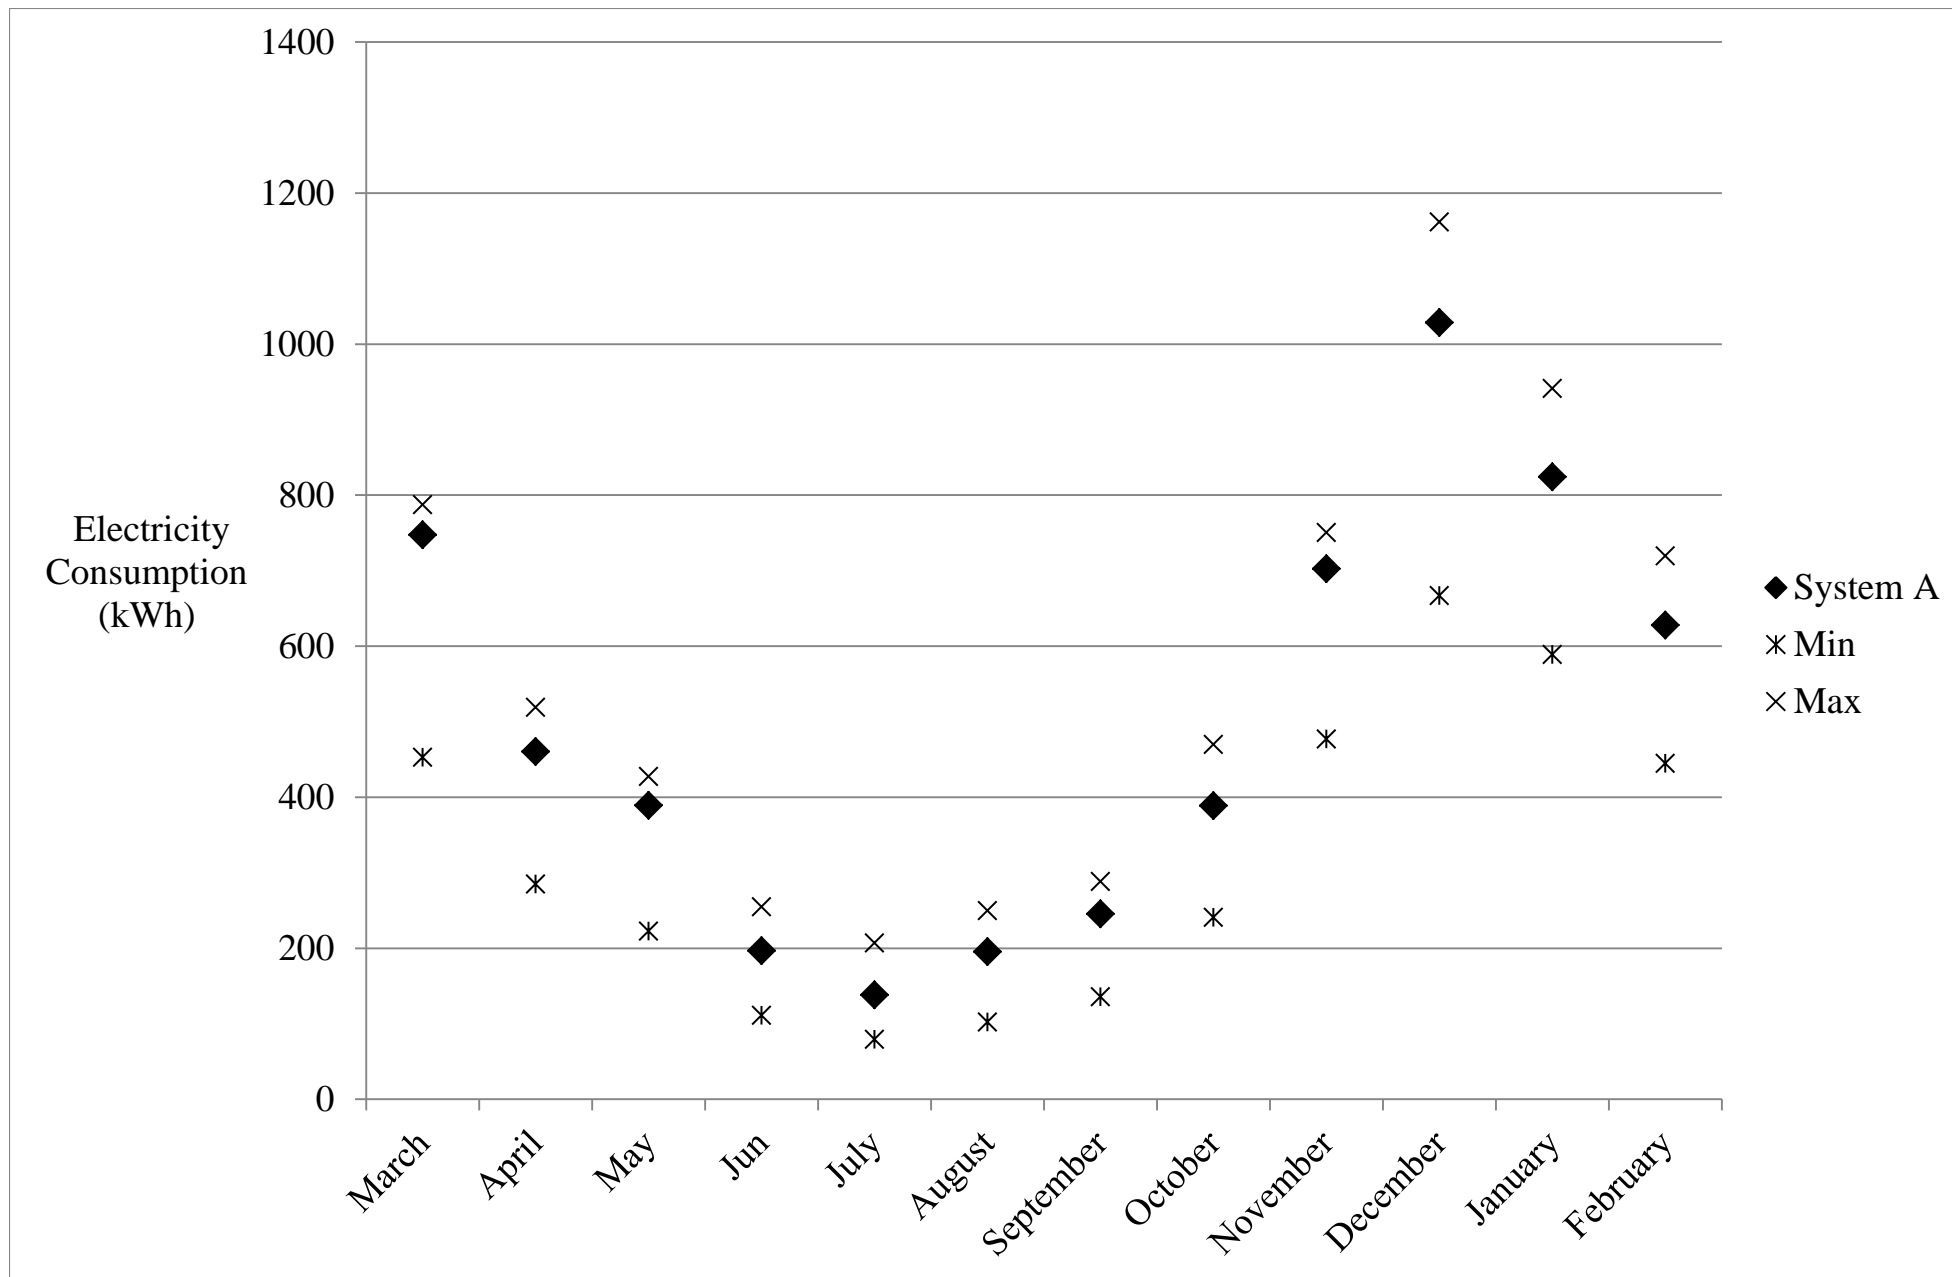
Fig 2: Month by Month Electricity Consumption of System A, compared with the maximum and minimum electricity consumptions from all 10 systems. .

Fig 2 shows a similar plot for the total electrical consumption of the heat pumps on a month by month basis.

Again, system A is at no time the maximum or minimum consumer of electricity within the group of 10 systems, but this time it is clear that during the colder months the consumption tends to be somewhat higher than average. Conversely during the summer months consumption is somewhat below average.

(Note that 4 days of consumption data for system A during October is missing due to a faulty transmitter, so this data point represents a slight underestimate of actual consumption).

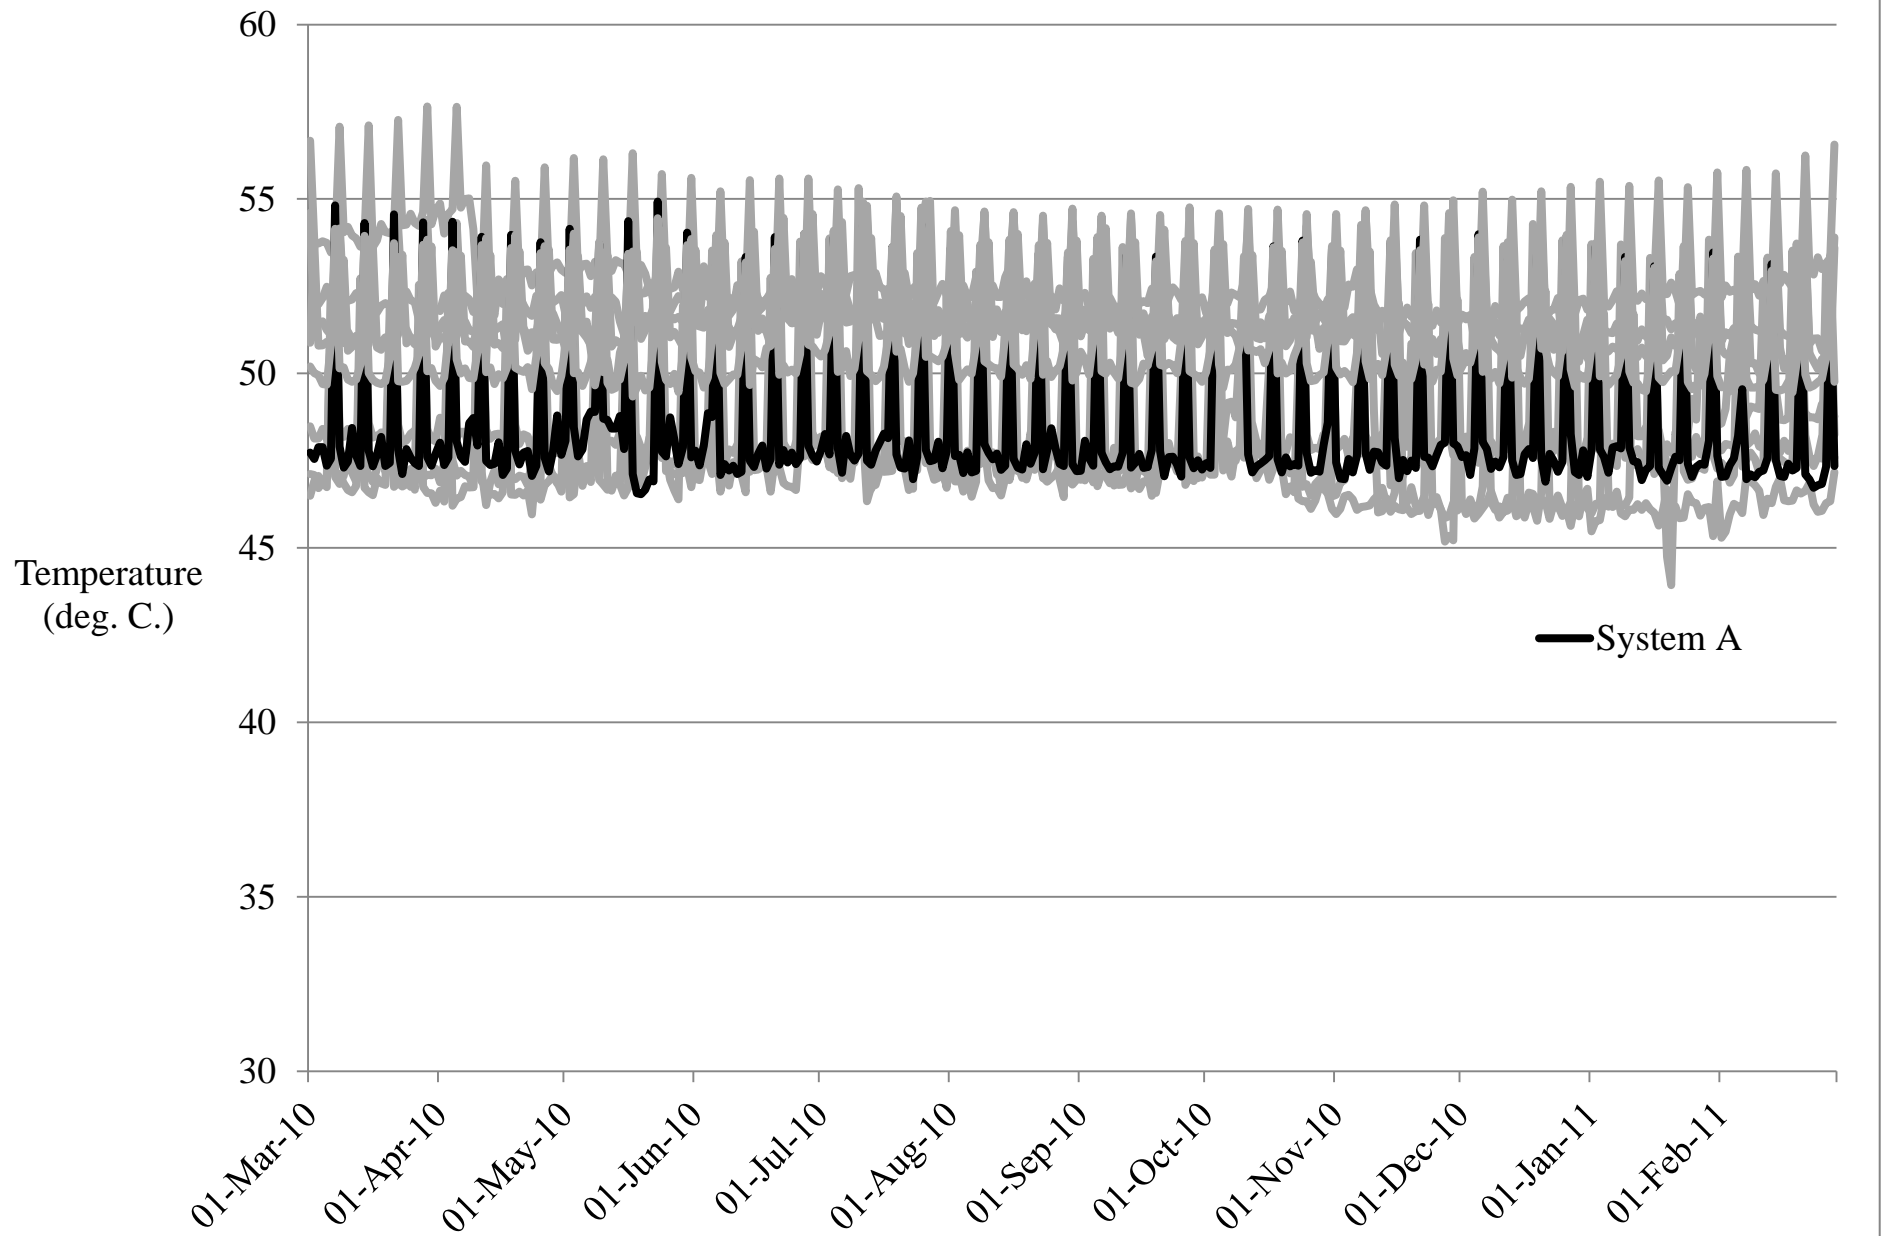
Fig. 3: Surface temperature at top of DHW tank. (Daily average calculated as a mean from data sampled at 10 minute intervals)

From Figs 1 and 2, we might expect that the set-point temperature for DHW in system A is set relatively low (leading to good efficiency and low electricity usage in the summer months). Fig 3 shows the daily average temperature as measured by surface probe at the top of the DHW tank for 9 of the 10 systems including System A. (The tenth system was excluded for reasons relating to system malfunctions). Clearly system A operates at a relatively low baseline DHW tank temperature as expected.

The regular peaks shown by the majority of systems represent weekly pasteurisation cycles where the tank temperature is raised briefly to 60°C to mitigate the risk of legionella growth.

However, since these are daily average values (averaged from data sampled at 10 minute intervals), all temperatures shown on the plot are in fact less than 60°C. There is a loss of pasteurisation cycle for one of the group from October onwards, but this is unrelated to the present discussion.

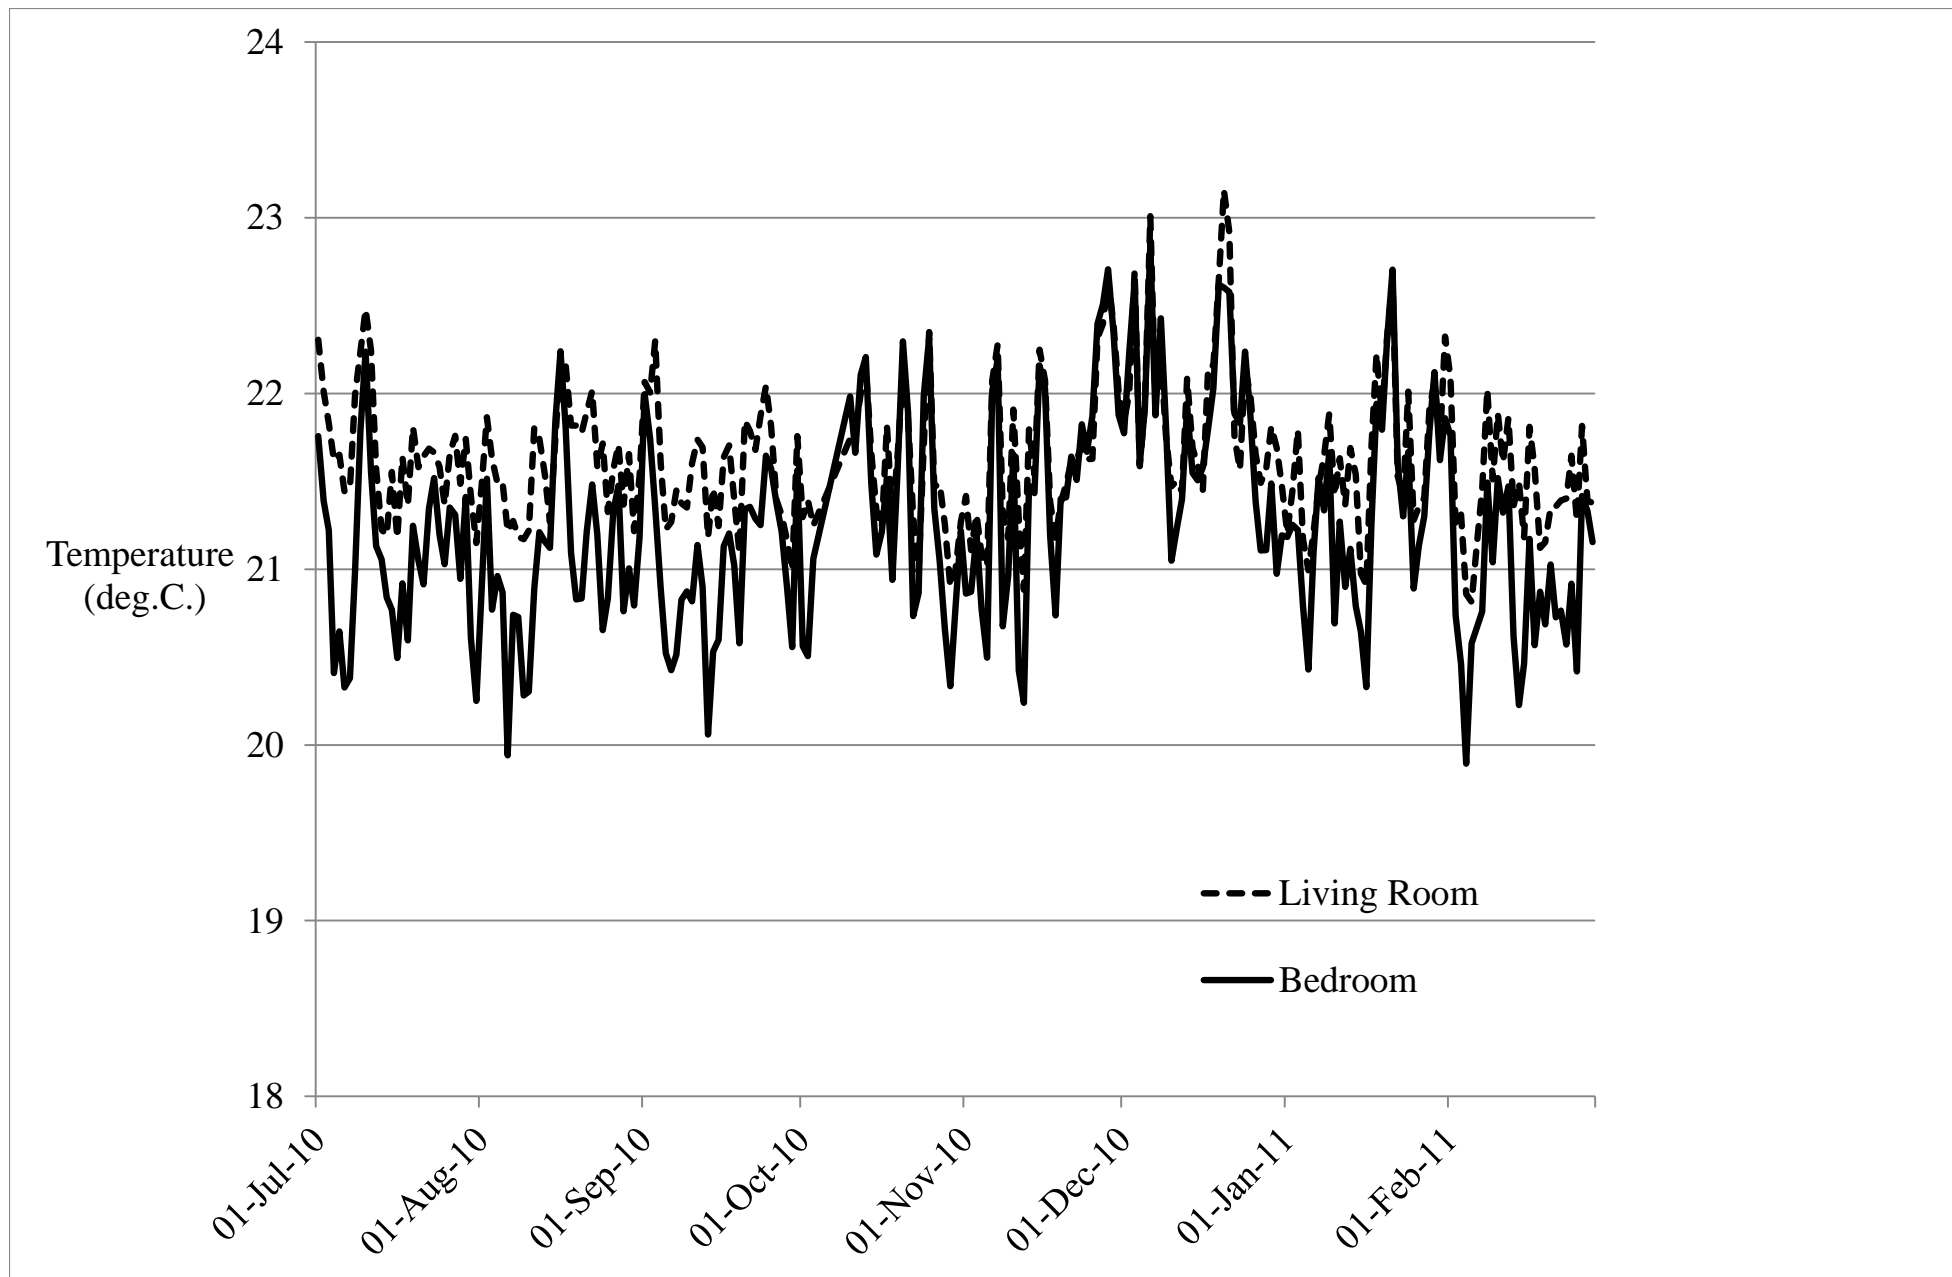
Fig 4: Daily Average Living Room and Bedroom Temperatures for system A (July 10 to February 11). (Daily average calculated as a mean from data sampled at 10 minute intervals).

Taking a simple view we might expect to see either fairly high internal dwelling temperatures, or low ground-loop temperatures, leading to relatively high electricity usage and lower efficiency during the heating season. Internal temperatures in the system A dwelling were measured in four locations (living room, bedroom, kitchen and bathroom) and found to be reasonably consistent and stable throughout the dwelling. Fig 4 shows living room and bedroom temperatures only for the sake of clarity, but kitchen and bathroom temperatures followed the living room temperature closely. The somewhat lower and less stable bedroom temperatures, during all of the year except for the coldest period in late November and December may be explained by the window-opening behaviour discussed in section 2.7.

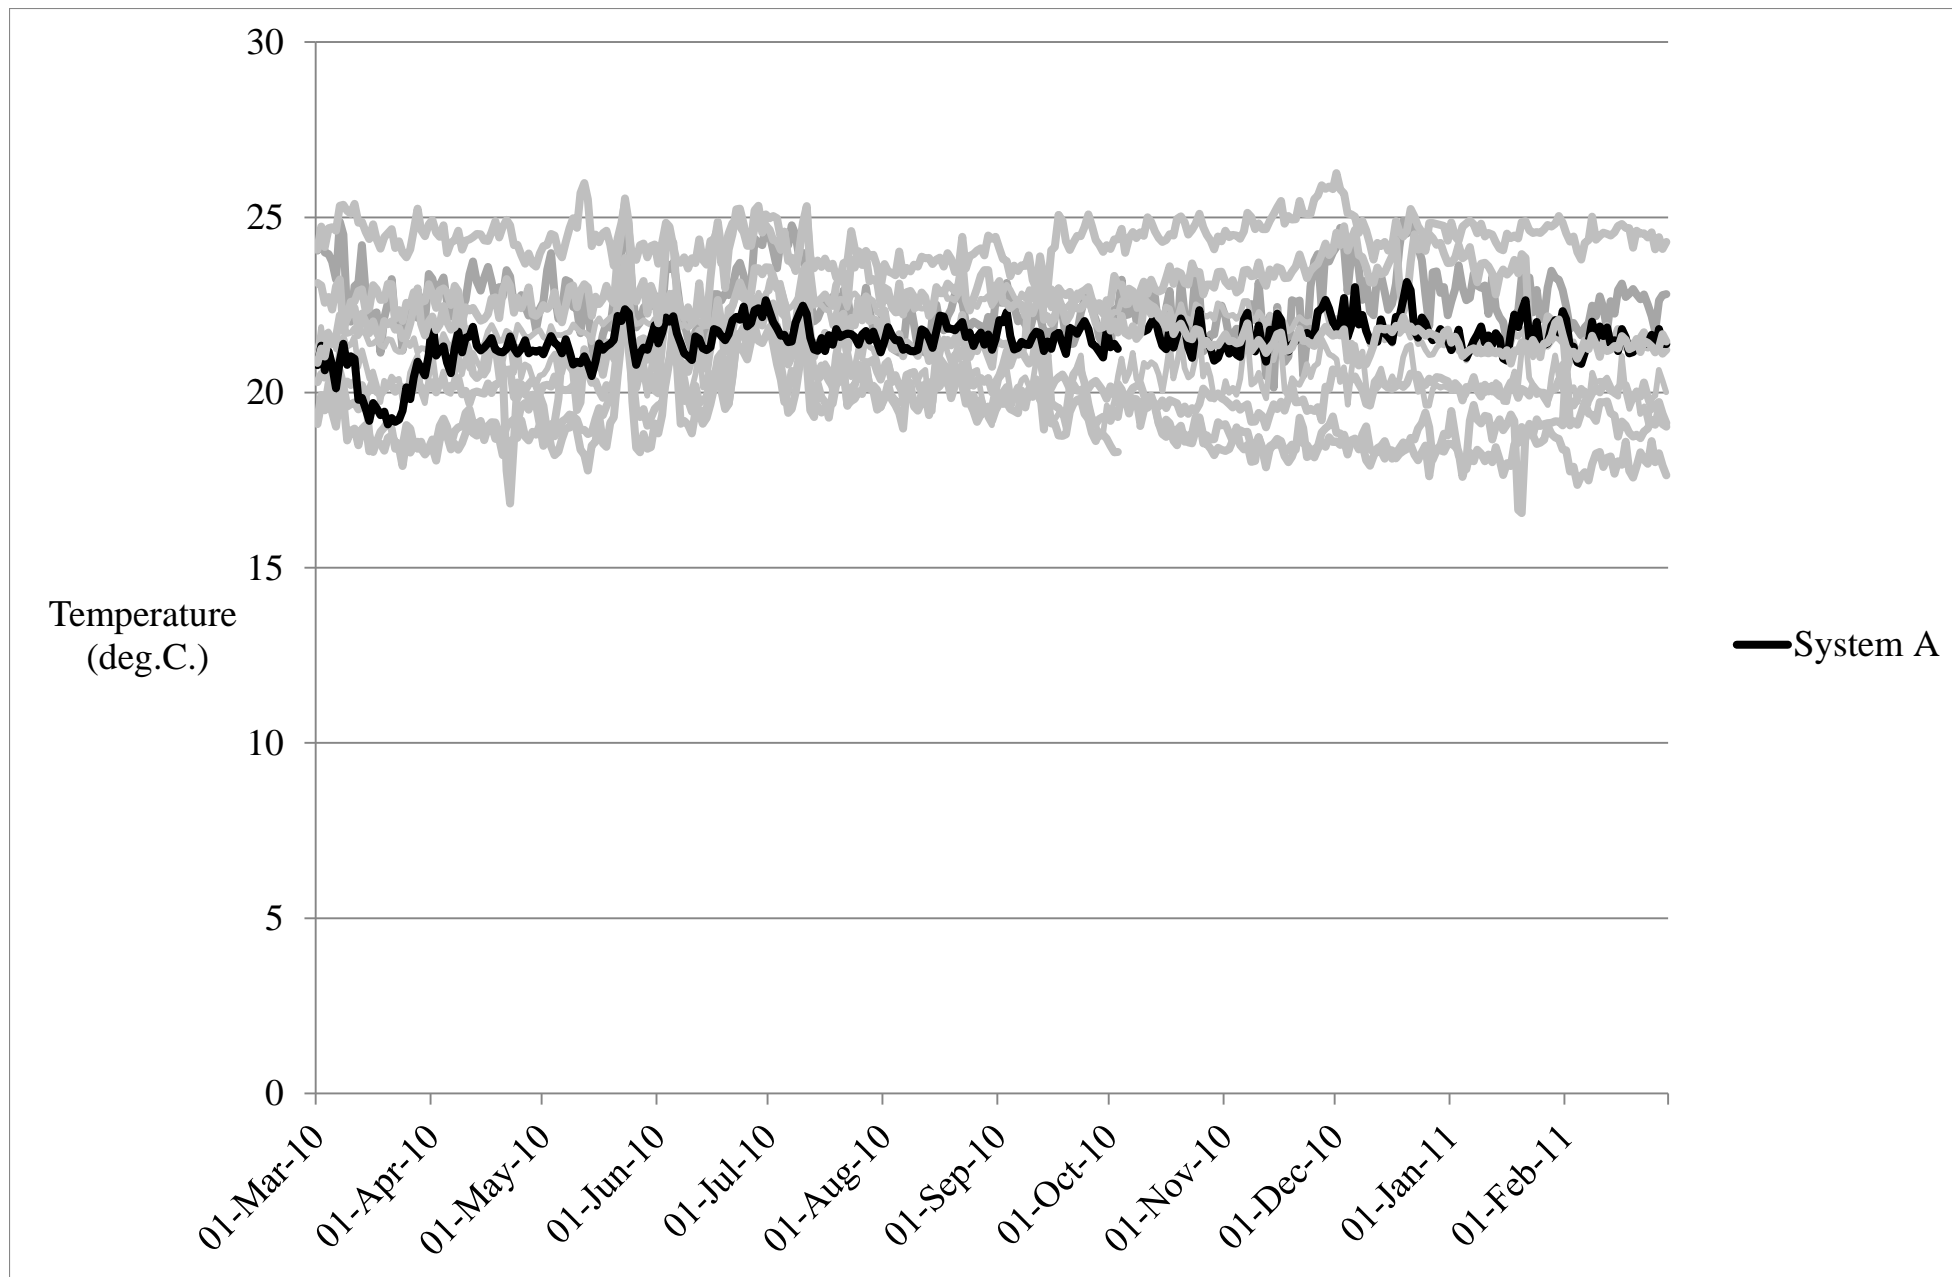
Fig 5: Daily Average living room temperatures – all systems. (Daily average calculated as a mean from data sampled at 10 minute intervals).

Figs 5 and 6 track the living room temperatures and ground-loop fluid temperatures for all the systems. In the case of Fig 6 the plot is restricted to the months of November and December 2010. A full year plot would be misleading since during the warmer months, when the heat

Figs 5 and 6 show that in the context of the other systems, system A is around average for both internal temperature and ground-loop fluid temperature. We might therefore expect to see average performance during the winter months, when the efficiency is dominated by space-heating, but in fact the performance tends to be below average. Factors which may cause this apparent anomaly are discussed in the following sections.

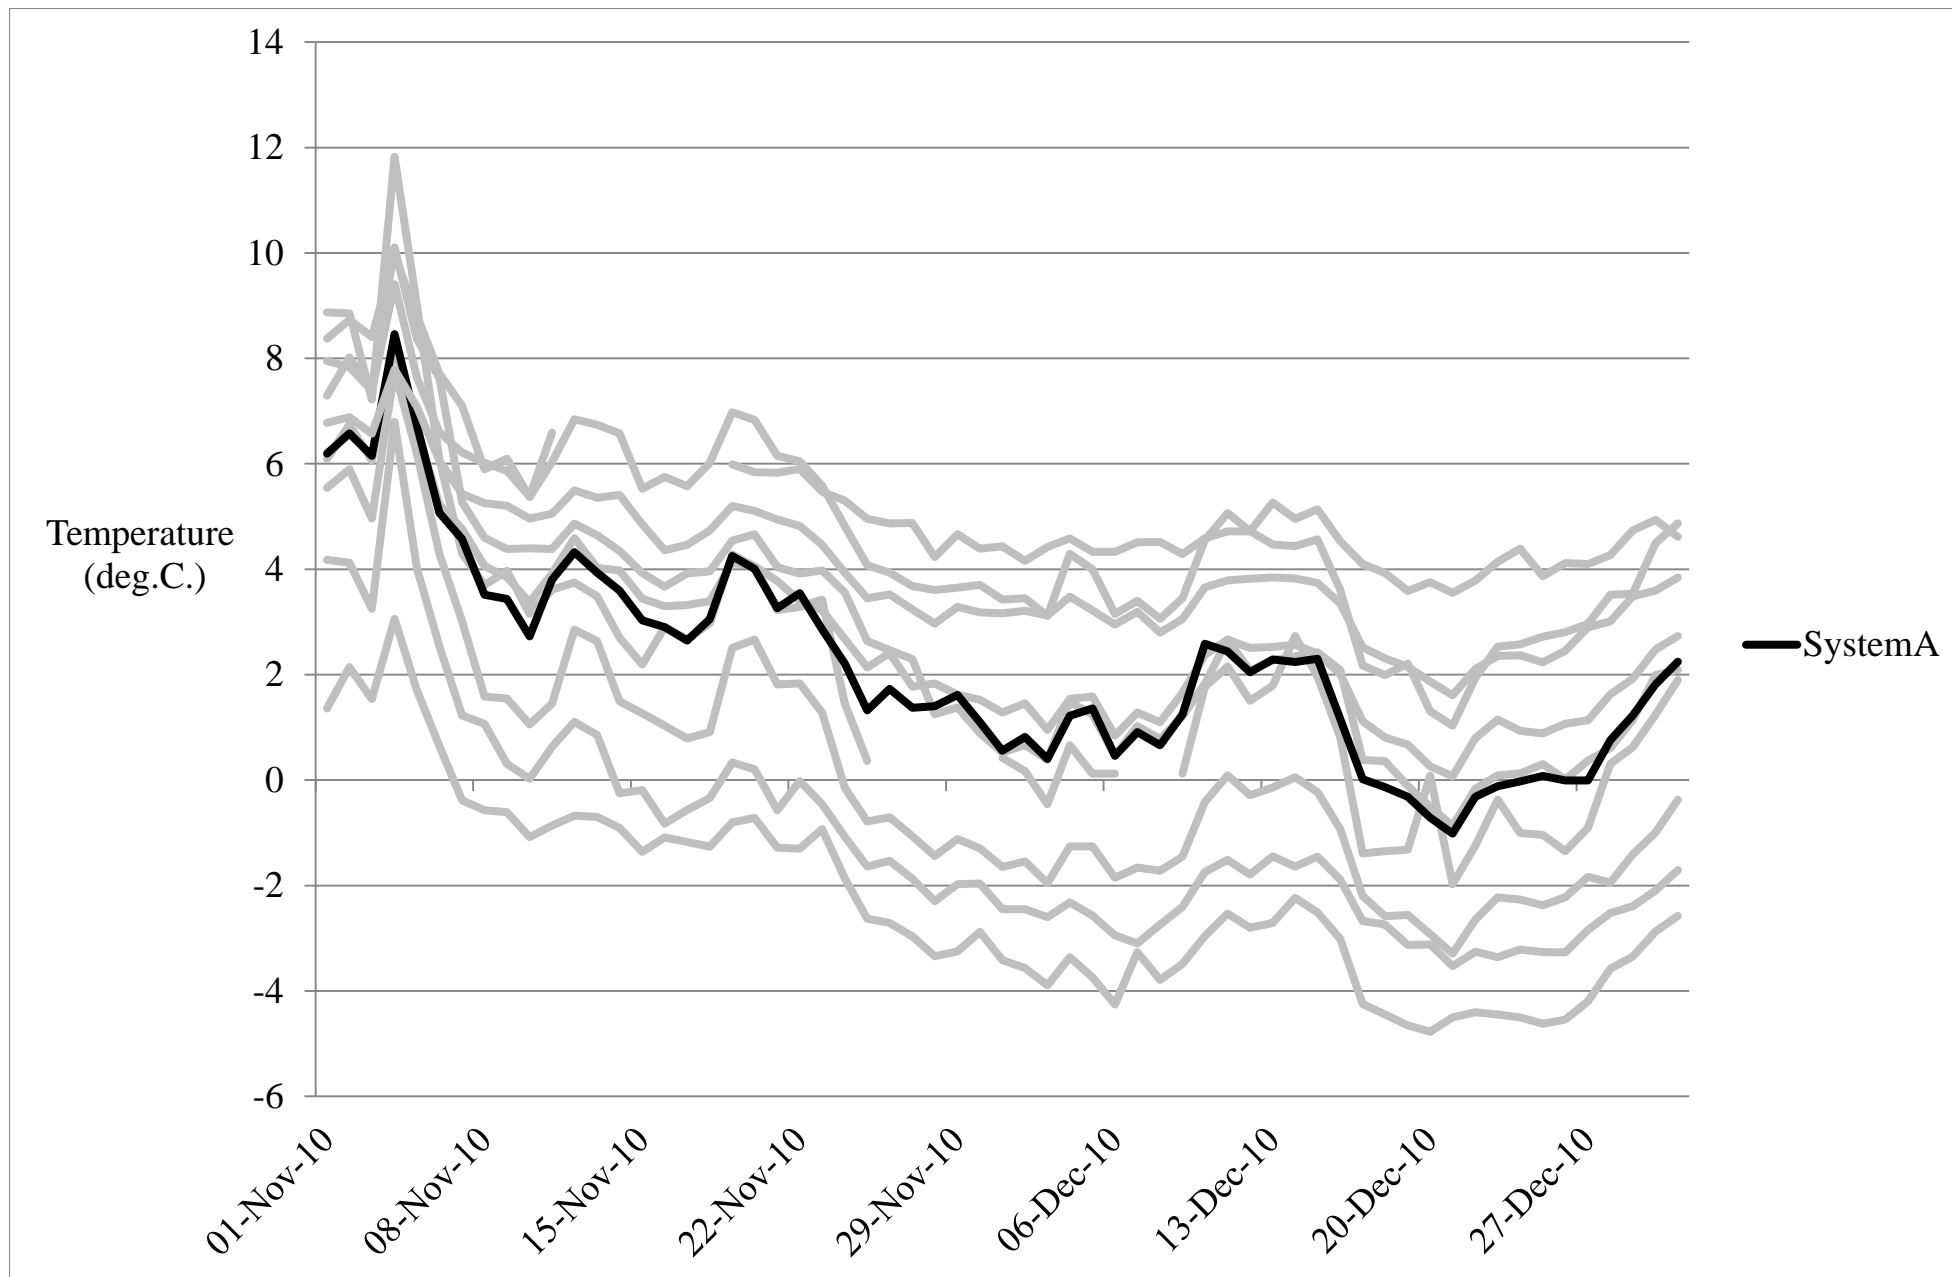
Fig 6: Daily Average Temperature of fluid from Ground Loop for all 10 systems (November/December 2010). (Daily average calculated as a mean from data sampled at 10 minute intervals).

pump is operating intermittently, the temperature measured may represent only that of stagnant fluid in the pipework.

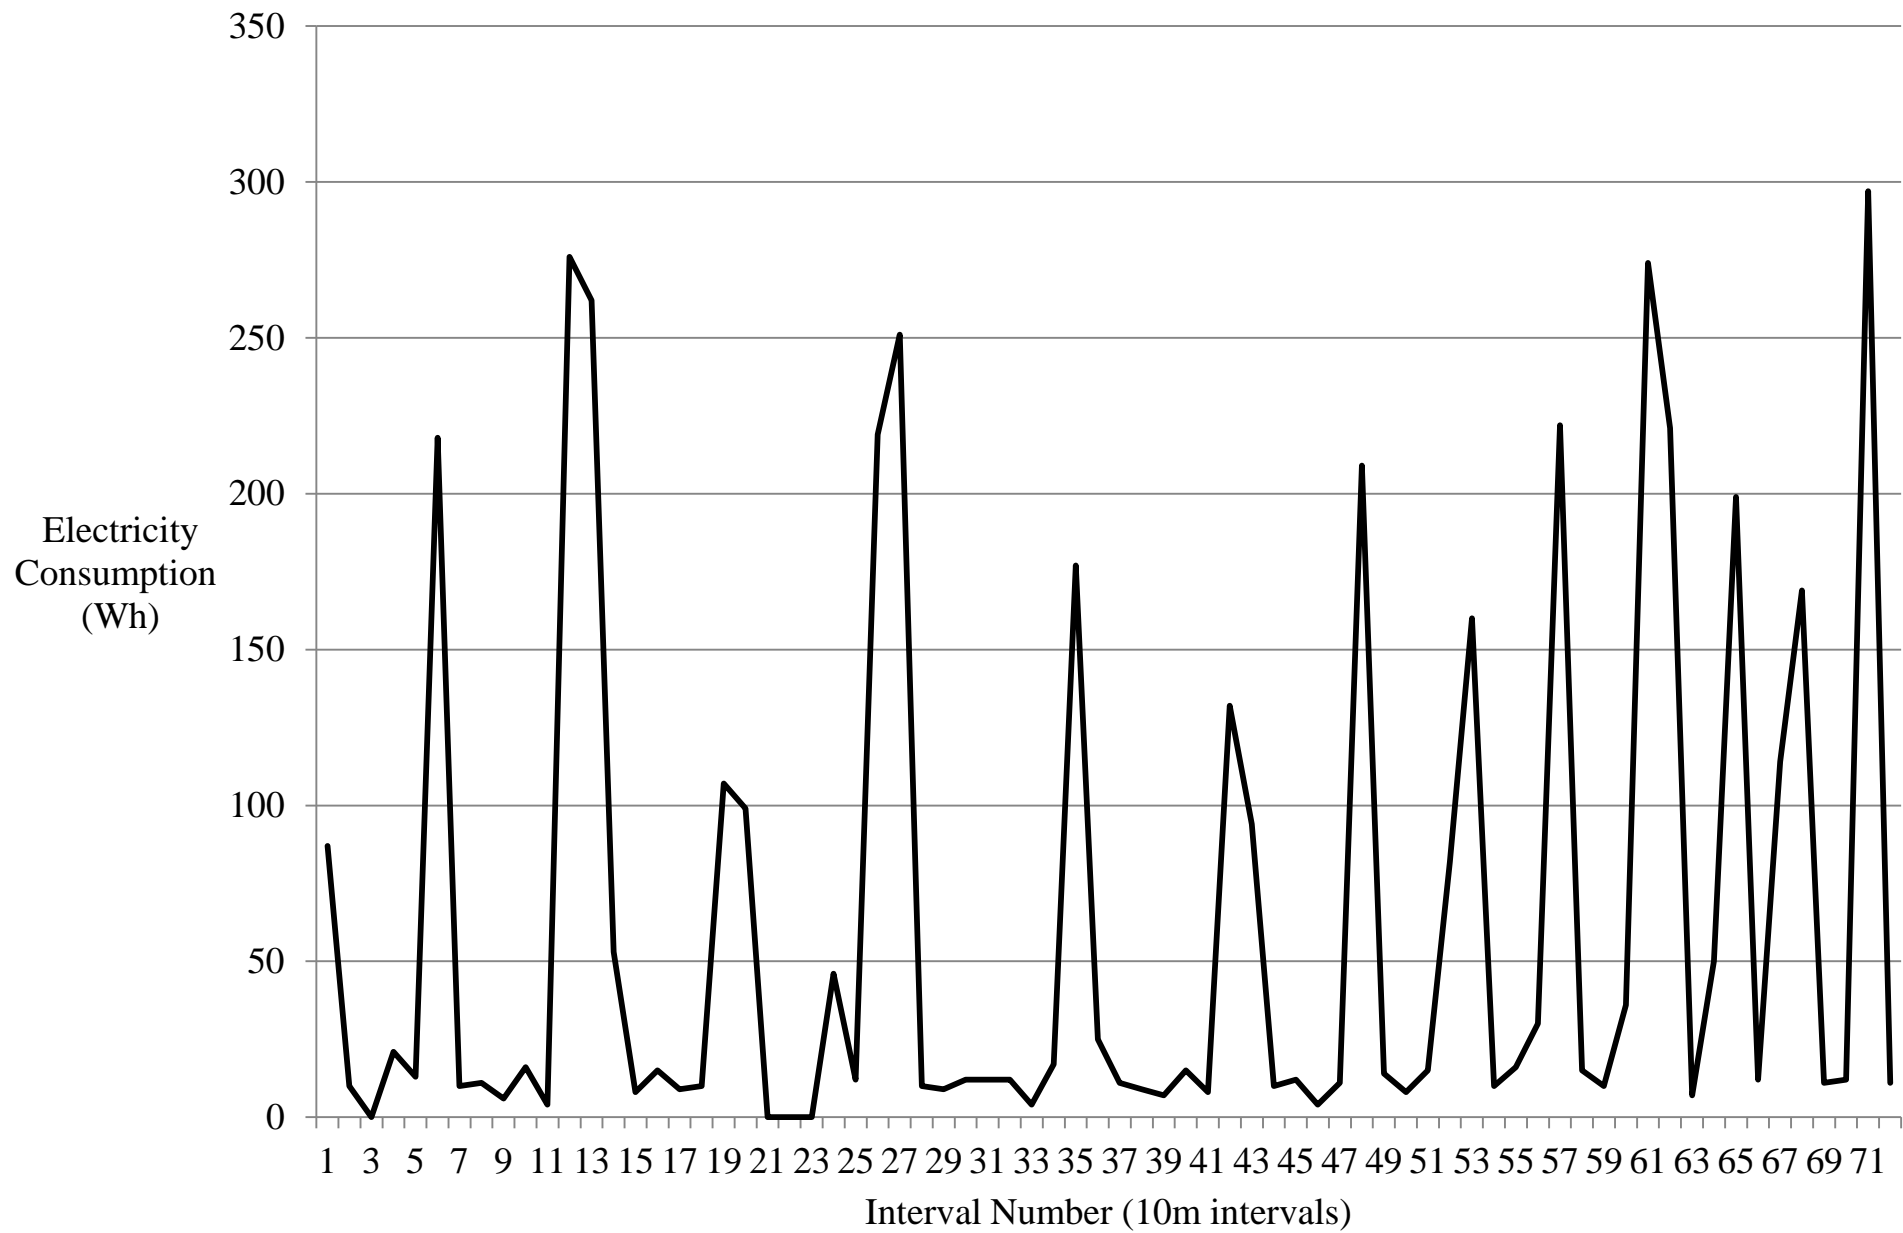
Fig. 7: Compressor cycling in System A.

The compressor cycling behaviour in system A, together with the other 9 systems is illustrated by looking closely at a 2-day period (1st- 2nd October 2010). October was chosen as a period when space heating could be expected to occur, but on the other hand demand was not so constant as to blur the distinction between on and off periods. For each system, the total heat pump electricity consumption was plotted at 10 minute intervals, and the clear peaks simply counted. Fig 7 gives an example of the type of data obtained, showing the period 12 noon – 12 midnight on 1st October for system A.

Whilst an element of human judgement exists in counting peaks in this way, it is nevertheless reasonably clear. Double peaks (i.e. where a shoulder exists on the main peak) are counted as one. It must be remembered however, that some of these peaks may be due to compressor start-up for the purpose of DHW production, and should therefore be discounted. It proved to be possible to separate the two by inspection using the data available in this study, since DHW tank temperature was monitored throughout, and so peaks coinciding with a rise in DHW temperature could be ascribed to DHW production. (DHW demand takes precedence over space-heating demand in these systems).

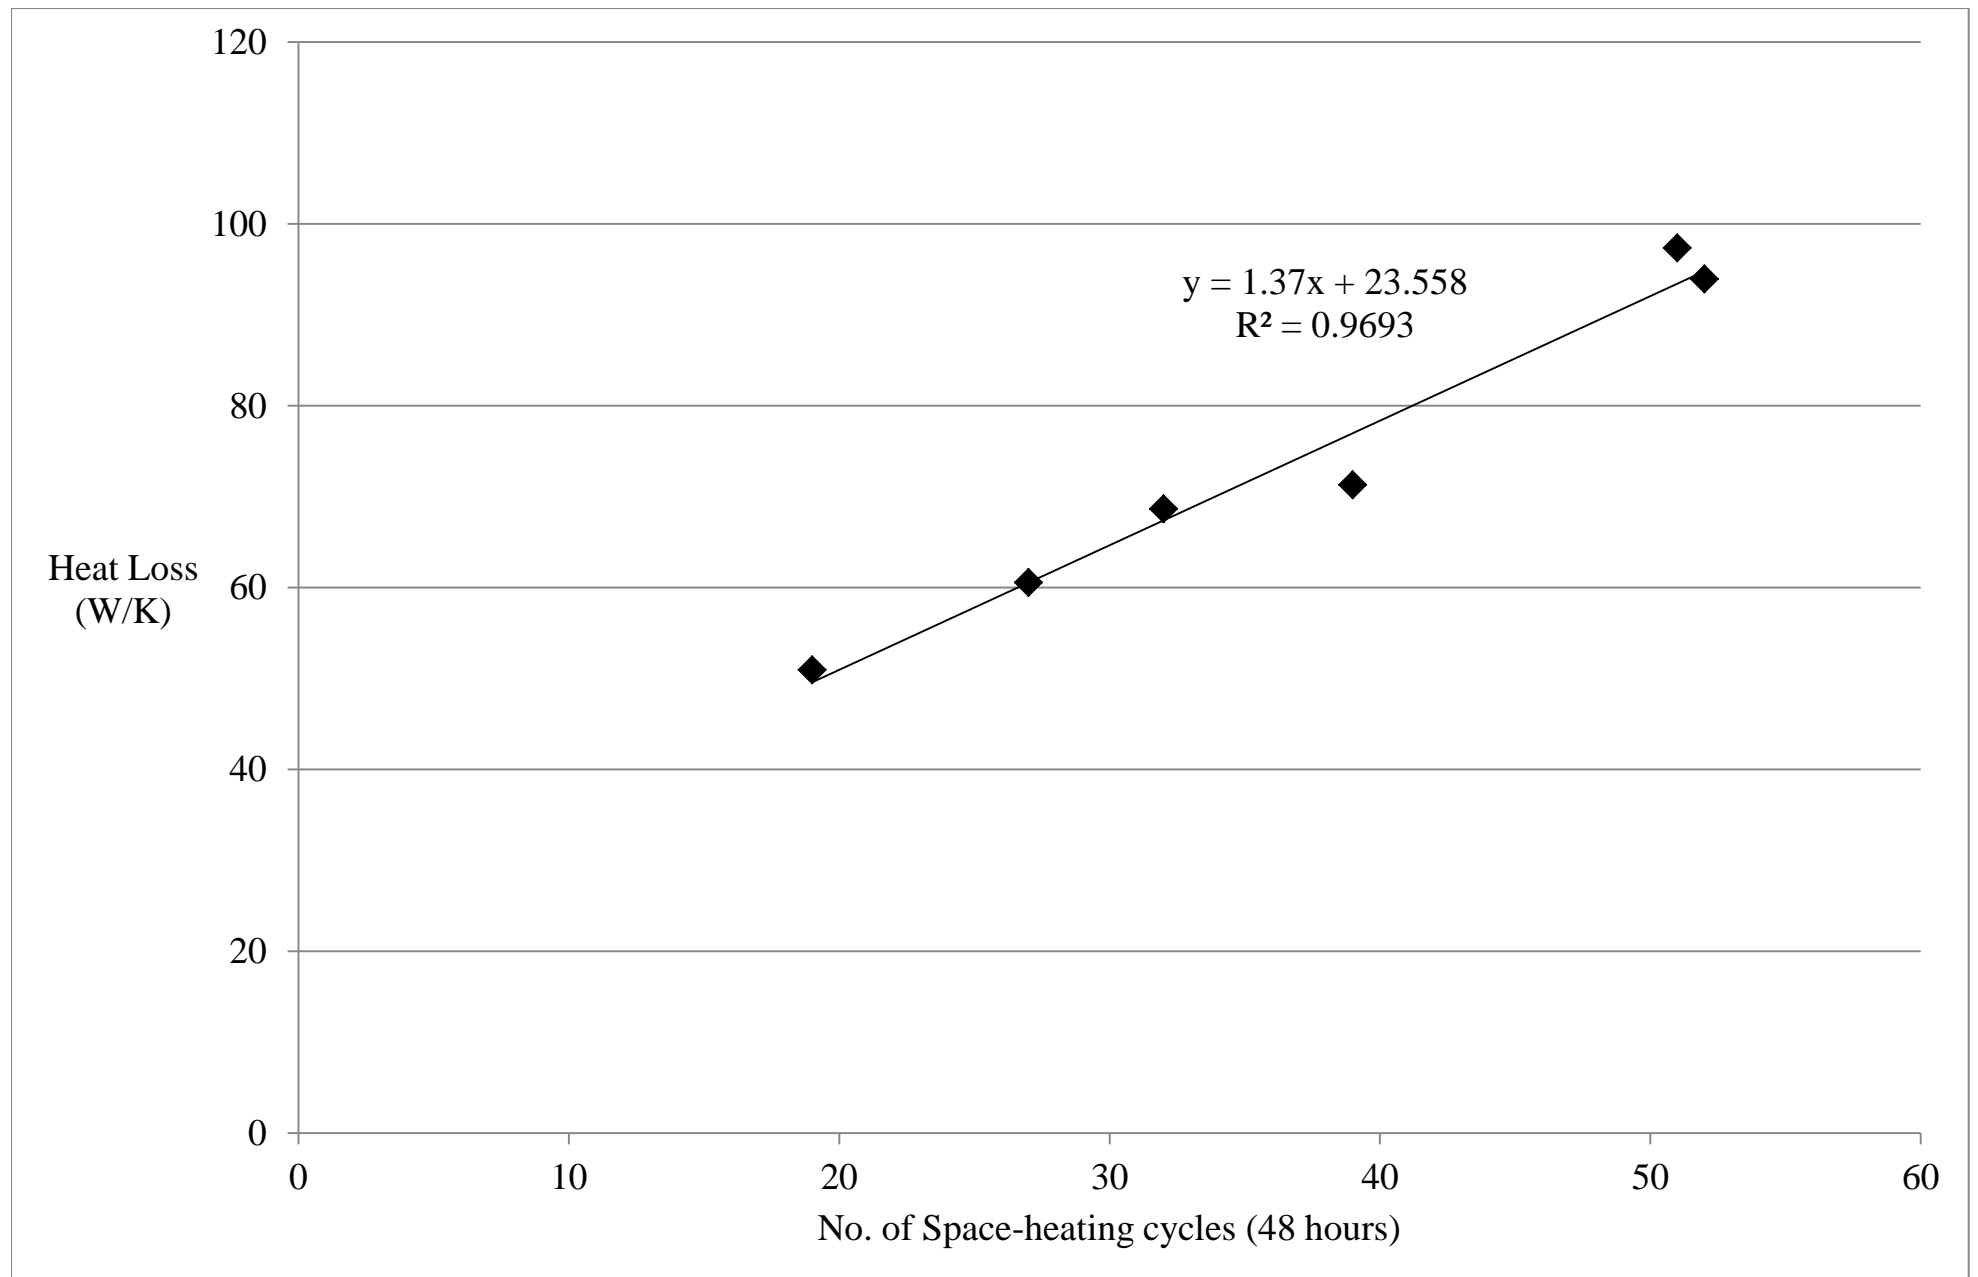
Fig. 8: Correlation of Space-heating Compressor Cycling with Estimated Daily Heat Loss rate (6 co-located systems).

Fig 8 shows a plot of the cycling attributed to space-heating vs the estimated daily heat loss rate in W/K, (average of 1st and 2nd October). The latter was calculated from space-heating heat output and temperature difference as measured by internal and external temperature sensors. This method assumes that the heat production rate of the heat pump (for space-heating) is equivalent to the heat loss rate from the building, which seems a reasonable assumption in view of the observed stability of internal temperatures. Of course it is understood that there will be other contributions to heat input to the building, such as metabolic and appliance gains, so the figures should not be taken as absolute values, but as indicative only.

Fig. 8 demonstrates that space-heating cycling rate can act as a good proxy for heat loss rate for these systems, under the conditions described. This is a potentially useful result since electricity consumption can be monitored more easily than heat output.
